# Ministry of the Environment, Conservation and Parks: Brenntag Canada Inc. Fire Off-Site Environmental Monitoring Summary Report Date: November 16, 2023

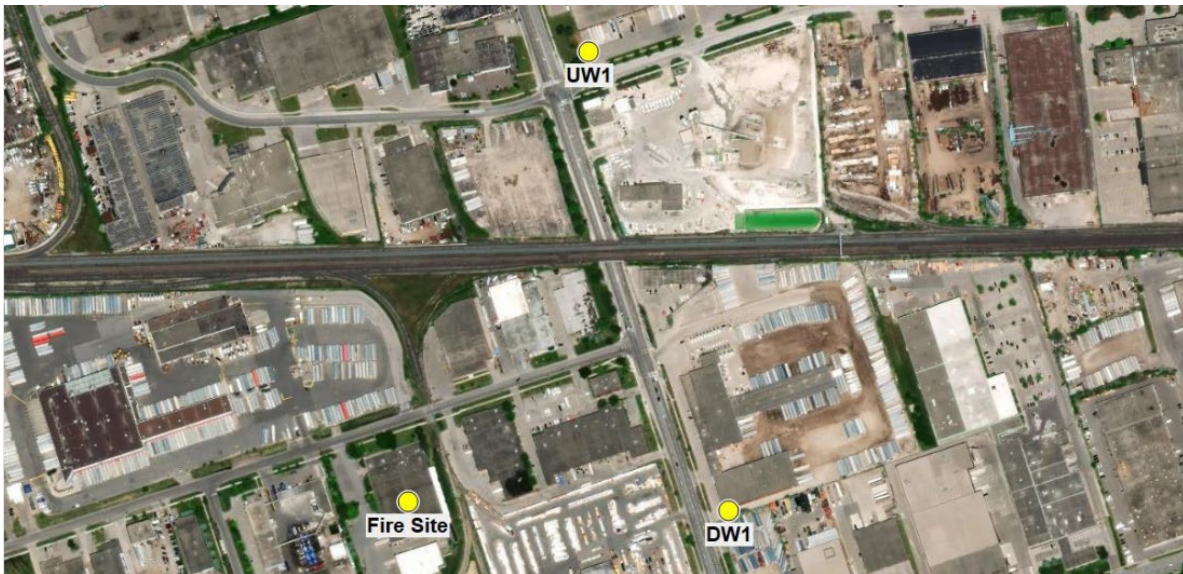
**Figure 1.** Mobile TAGA Monitoring sites. UW1, DW1 and Fire Site indicate the upwind monitoring location, the downwind monitoring location, and the location of the active fire.

The ministry's mobile trace atmospheric gas analyser (TAGA) arrived on the scene on the morning of August 11, 2023, to undertake ambient air quality monitoring in the vicinity of the fire in support of First Responders and emergency response (Figure 1).

On August 11, 2023, the ministry's mobile trace atmospheric gas analyzer (TAGA) unit measured air pollutant concentrations in the vicinity of the fire for approximately three hours between 11:26 am and 2:30 pm.

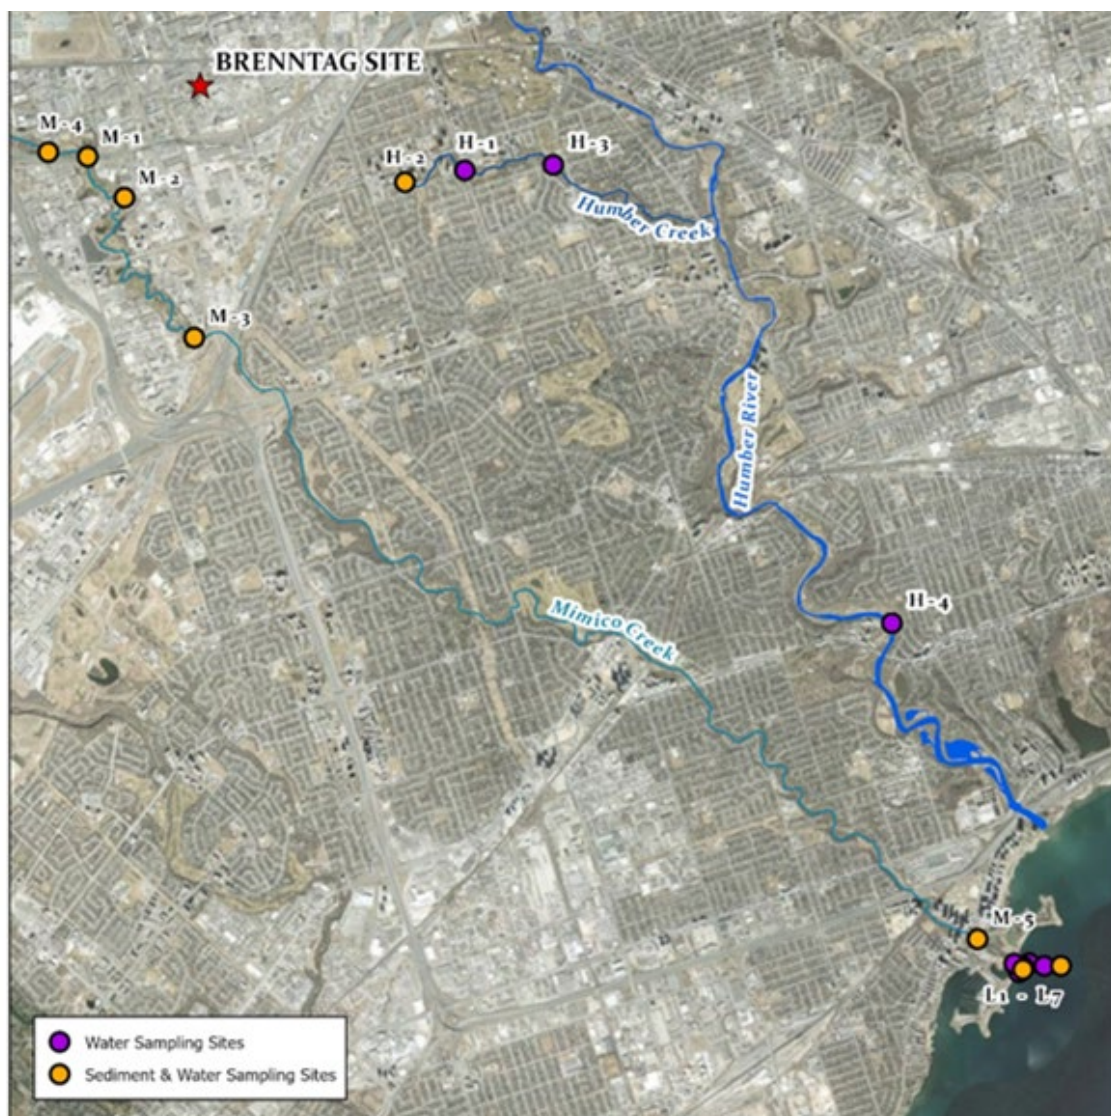
**Figure 3:** Ministry Water Sampling locations along Mimico and Humber Creeks, the Humber River and Lake Ontario.

The ministry collected water samples to characterize and document contamination downstream of the discharge points and assess the extent of environmental impacts in Mimico Creek and Humber Creek/Humber River towards Lake Ontario. Five water monitoring locations were established along Mimico Creek and three along Humber Creek, located at successive points downstream of spill containment booms. Additional water monitoring locations were established in Mimico Creek near the mouth of Lake Ontario, in the Humber River and Lake Ontario. An upstream reference site was also established in Mimico Creek (Site M4) to collect information on background water quality conditions (Figure 3).

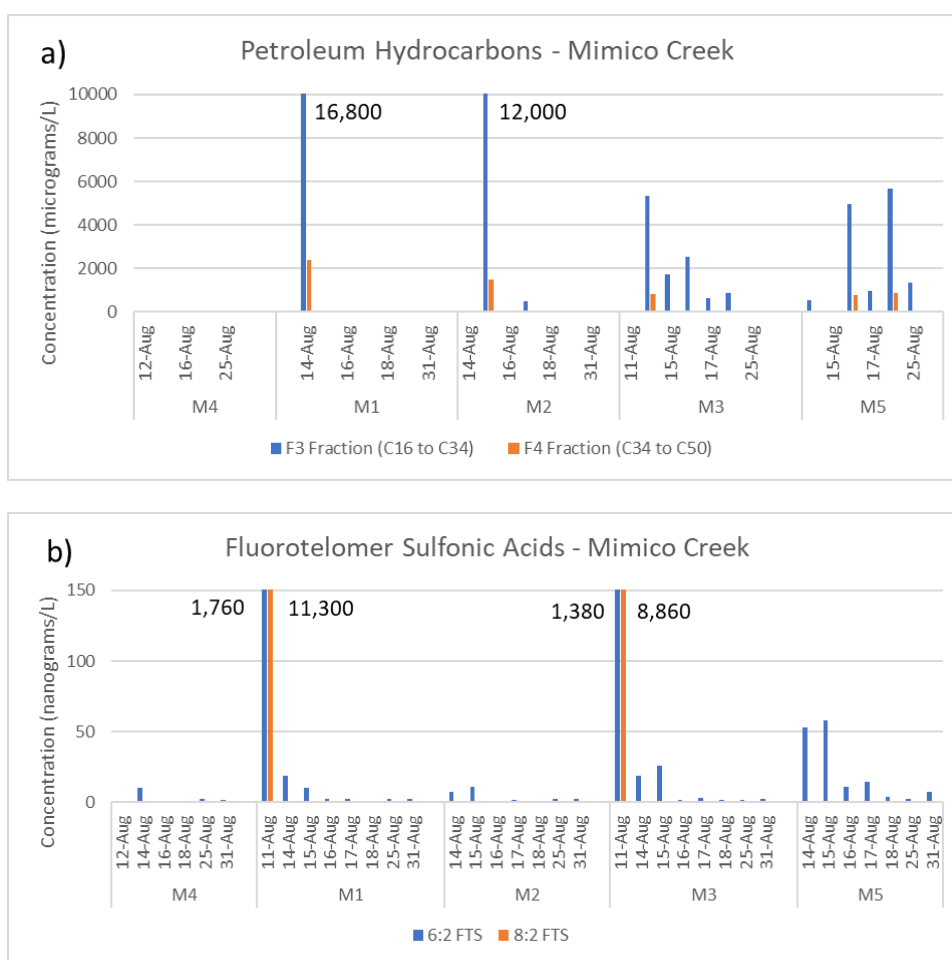
Compounds associated with petroleum hydrocarbons were initially observed in the water samples at elevated concentrations, relative to the upstream Mimico Creek reference site, at the discharge points in Mimico Creek and Humber Creek immediately following the fire. Concentrations decreased with distance from the discharge points in both creeks. Concentrations at these sites also decreased over time (Figure 4a).

Elevated concentrations of the fluorotelomer sulfate (FTS) PFAS compounds were present in the water samples shortly after the fire, relative to the upstream Mimico Creek reference site. The source of these compounds may have resulted from the use of fire-fighting foams during the response to the fire. Concentrations of these compounds returned to and remained at the same levels as the upstream reference location shortly after the initial sampling. There does not appear to be any lasting elevated PFAS contamination in water resulting from the fire-fighting activity during this incident (Figure 4b).

**Figure 4:** Concentrations of (a) Petroleum hydrocarbons and (b) Fluorotelomer sulfonic acids (PFAS compounds) in Mimico Creek waters.

Concentrations of petroleum hydrocarbons and fluorotelomer sulfonic acids observed in the water are consistent with point source inputs from the storm water outfalls to Mimico

Creek and Humber Creek resulting from the fire suppression activities on the Brenntag property. Ongoing sampling indicates that the levels observed have returned or are returning to urban background conditions. The water sampling results suggest there is little residual contamination remaining in these two watersheds following the incident.

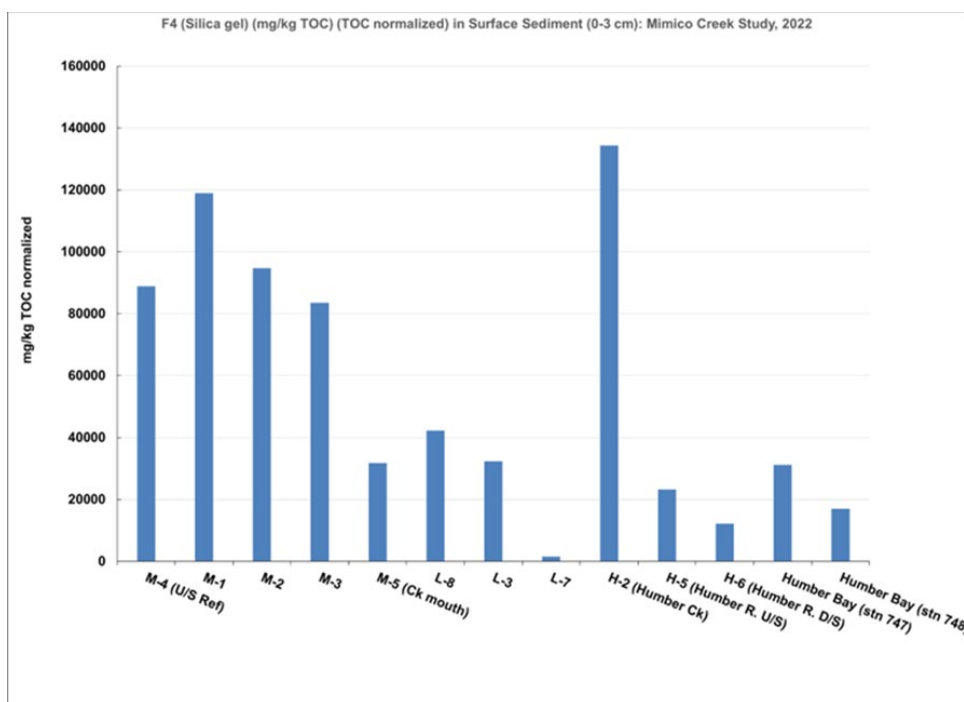
Sediment collected from one of the two storm sewer outfalls into Mimico Creek (Site M1; 286 Attwell outfall), and from Humber Creek (H2; near Acme Crescent) had the highest concentrations of petroleum hydrocarbons compared with other locations sampled in the survey. Concentrations (normalized for total organic carbon) observed in the sediments decreased with distance downstream. The observed patterns in sediment concentrations are indicative of a point source and are consistent with the release of materials such as the oil/grease emulsion from the fire site.

**Figure 6:** Concentrations (mg/kg total organic carbon (TOC)) of petroleum hydrocarbons in sediment collected from Mimico Creek, Humber Creek, Humber River, and Lake Ontario, August 31, 2023.

Concentrations of petroleum hydrocarbons in sediment samples are consistent with point source inputs from the storm water outfalls to Mimico Creek and Humber Creek resulting from the fire suppression activities on the Brenntag property. Ongoing sampling indicates that the levels observed have returned or are returning to urban background conditions. The sediment sampling results suggest there is little residual contamination remaining in these two watersheds following the incident.
